**PRE-PURCHASE VISUAL
STRUCTURAL INSPECTION
REPORT No. 824**

PROPERTY ADDRESS: Mindarie

DATE: 24 April 2017 TIME: 11.00am WEATHER: Fine

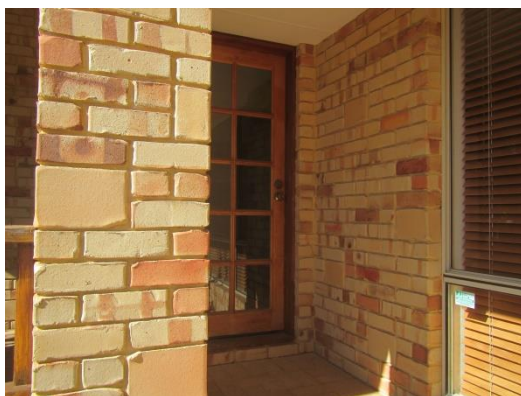
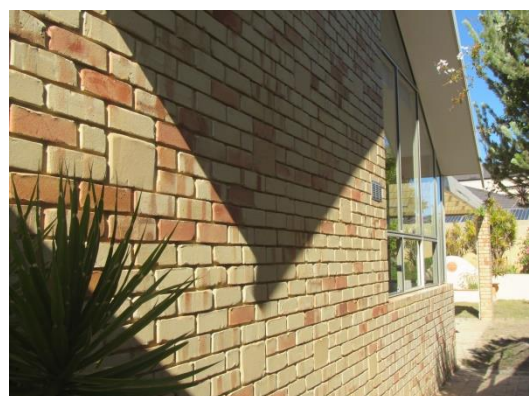
- a) The external face brick walls, where viewed, are in good condition for the age of the property and show no evidence of any major structural faults.
- b) A few movement cracks were noted which are typical in established homes. These cracks appear to be caused by minor settlement and are of no structural concern. It is always recommended to monitor cracking and consult a structural engineer if further movement occurs.

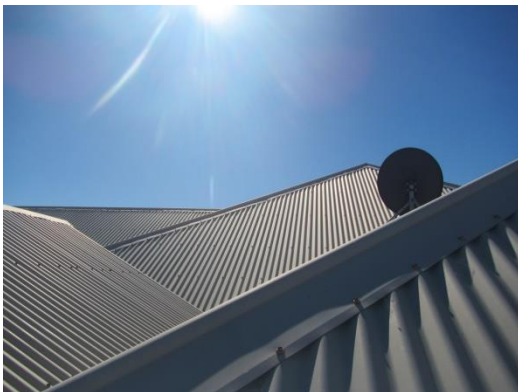
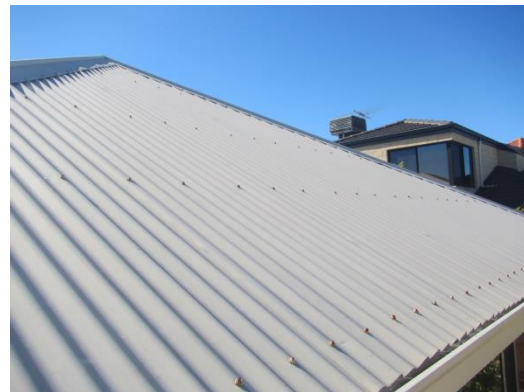
a) The colorbond metal roof, in areas viewed, is in good condition for the age of the property and there did not appear to be any major sagging issues.

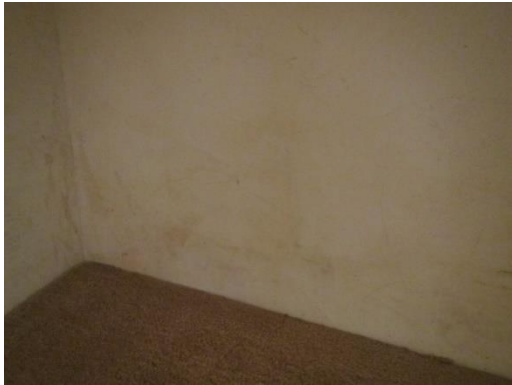
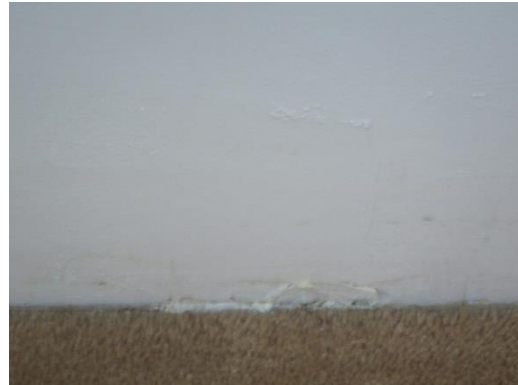
b) Some minor wall cracks were noted which appear to be caused by minor settlement. These can be patched by a plasterer or painter but should be continually monitored. Should any cracks continue to move consult a structural engineer.

c) It appears the shower grouting to the Bathroom may have broken down and caused moisture damage to the reverse side of the wall. This is a very common issue with showers. Generally dampness issues are not part of a structural inspection, but in the opinion of the inspector, because the dampness has penetrated to the adjoining room it could be deemed a defect and possible health issue. It is recommended the cause be confirmed and the shower resealed by a professional company. Refer to the terms of the offer and acceptance to confirm liability for the rectification work.

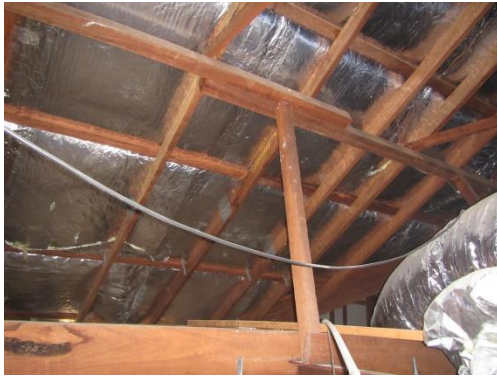
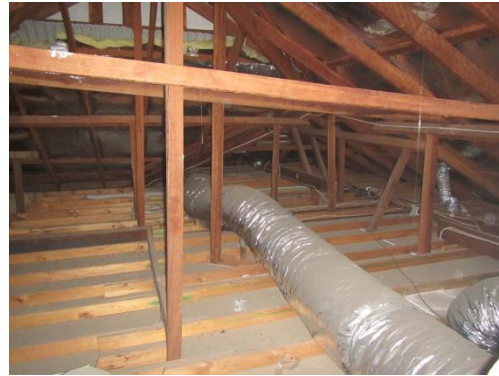
a) The roof structure of the main house is of timber construction and found to be in a satisfactory condition and appears to have performed adequately. The roof is constructed with W.A. hardwoods and pine and where observed was found to be in a reasonable and stable condition, generally straight and solidly built. The roof was inspected from a manhole in the ceiling.

b) The roof is insulated with anticon insulation under the roof sheeting. It is recommended insulation be installed on top of the ceiling to further increase the energy efficiency of the home.

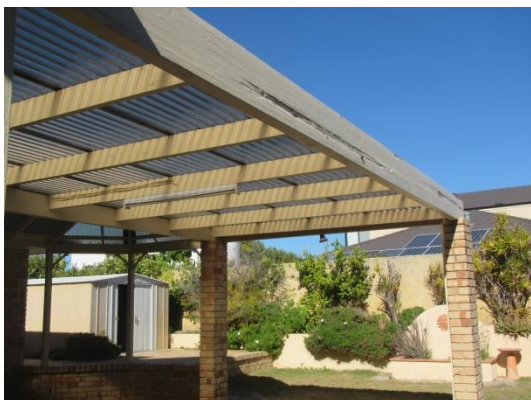
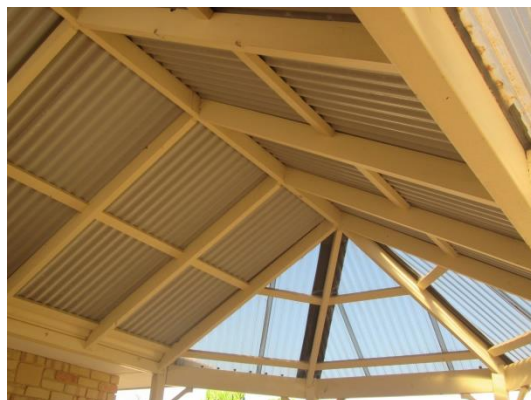
a) The roofed Patio is in sound condition and the timber roof structure appears to be performing adequately.

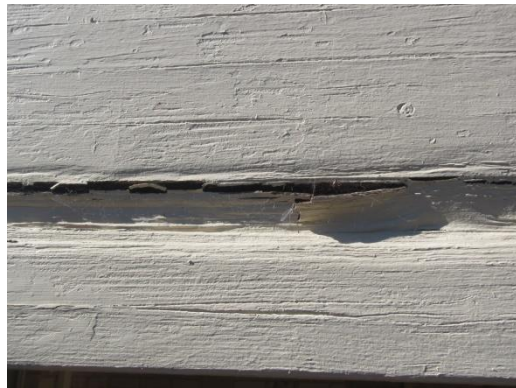
b) The main timber glulam beam is showing signs of rotting. It is recommended treatment be carried out to prevent further deterioration and regular maintainance is advised.

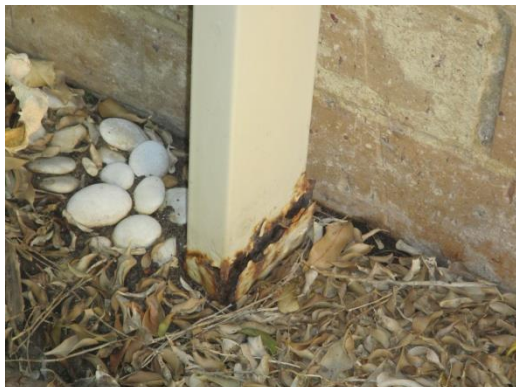
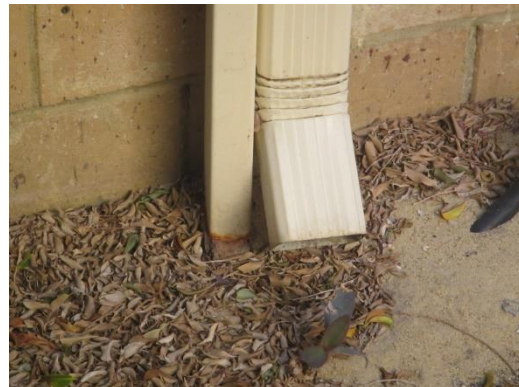
c) The metal posts have rusted severely at the base causing a weakness and in the opinion of the inspector is deemed a structural defect. Due to the extent of the rusting there is a strong possibility the post could fracture in heavy winds. It is recommended the post be rectified by a qualified person.

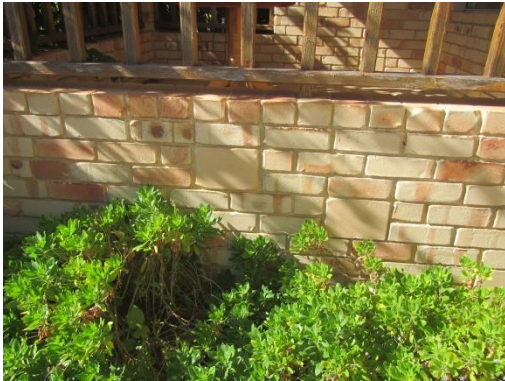
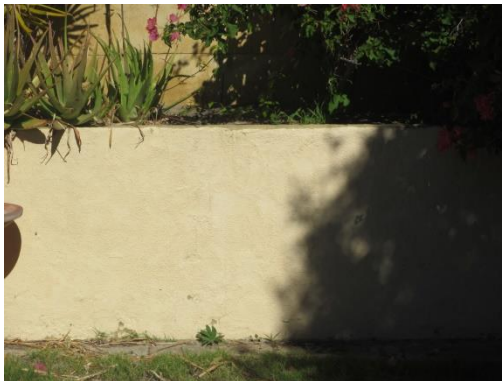
a) The brick retaining wall is in a satisfactory condition and no major failure was observed. Some movement cracks were noted which should be monitored. Contact a structural engineer if any movement continues.

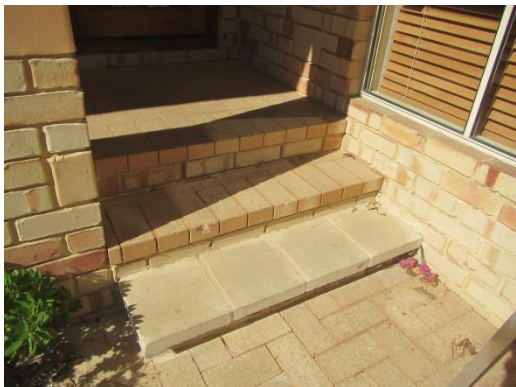
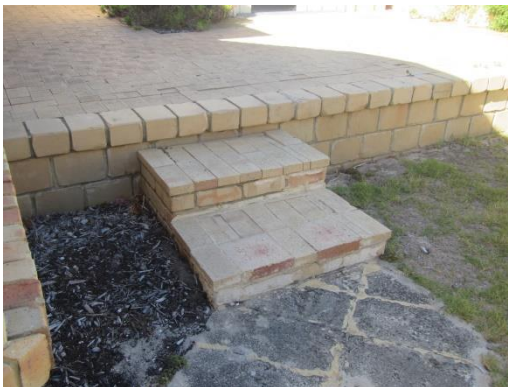
- a) The paved steps are in a satisfactory condition.

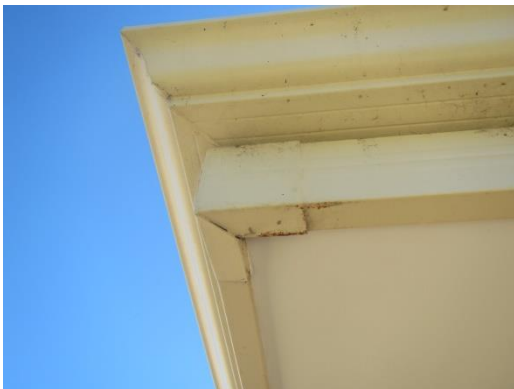
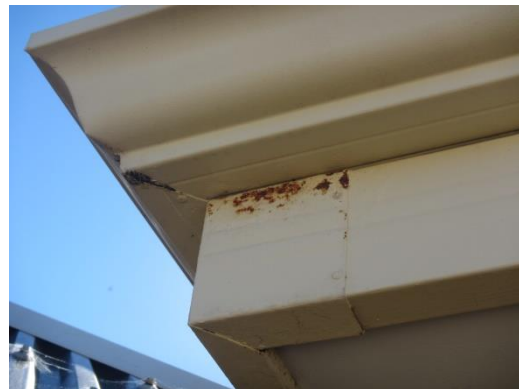
b) Rusting is starting to occur in various areas to the fascia and gutters. It is recommended treatment be carried out to prevent further deterioration.

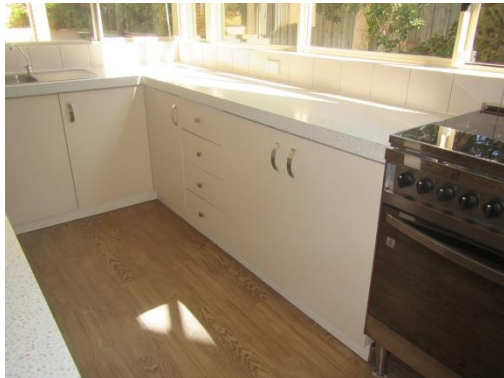
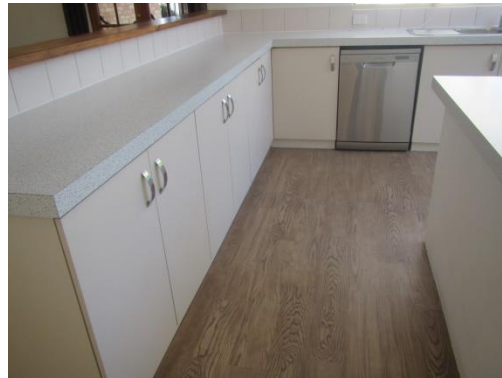
a) All cabinets including Kitchen, Laundry, Bathroom and Ensuite are in a satisfactory condition for the age of the property.

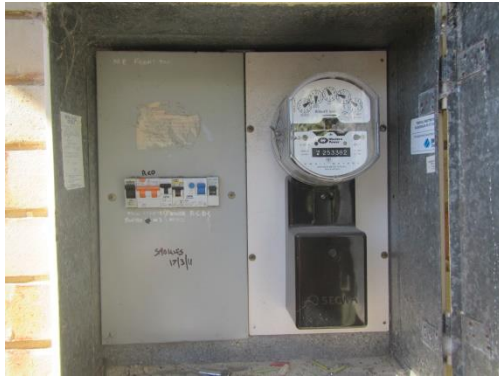
a) It is a requirement that hard wired smoke detectors are installed in close proximity to Bedroom areas prior to change of ownership. Smoke alarms were sited but not tested.

b) It is a requirement that RCD Safety Switches are installed to the power and lighting circuits prior to change of ownership. RCD safety switches were sited but not tested.

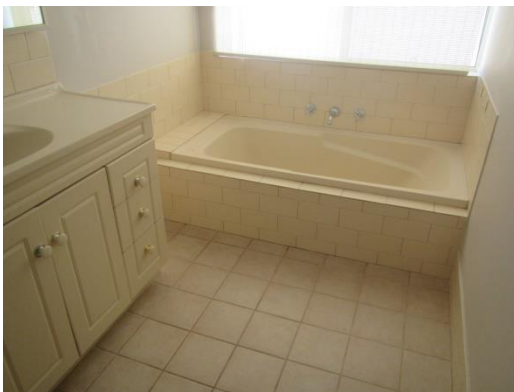
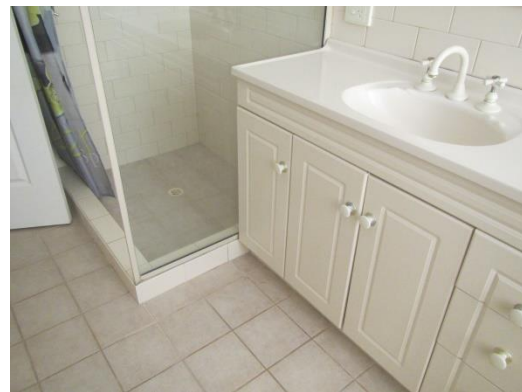
a) The Bathroom was checked and generally found in a satisfactory condition for the age of the property. The vanity doors require adjusting. **Please refer to Item “C” under internal walls.**

b) A maintenance issue which should be continually monitored are the joints between vanity tops, fixtures and tiles. These tend to break down in time and may allow water to penetrate.

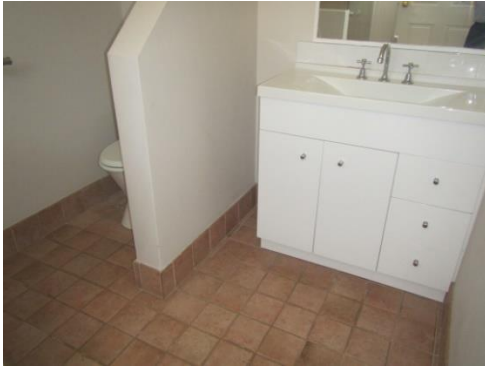
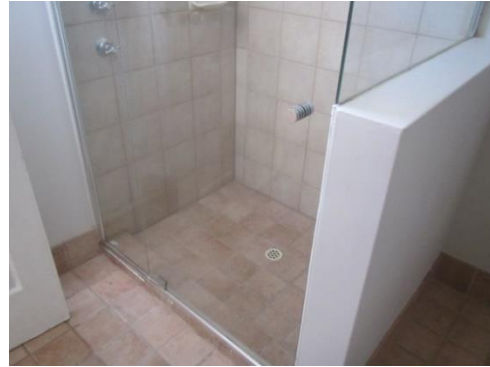
b) There is no evidence of major dampness from the shower cubical viewed. Shower cubicals tend to leak over time due to the break down and cracking of grouting. These areas should be continually monitored.

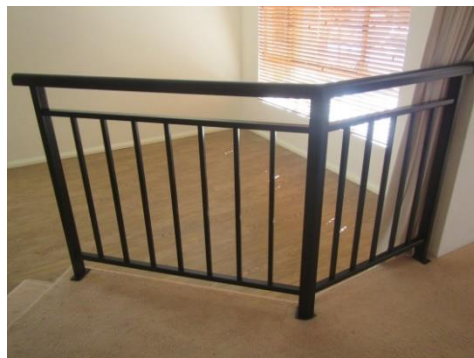
a) The internal balustrading is in a satisfactory condition.

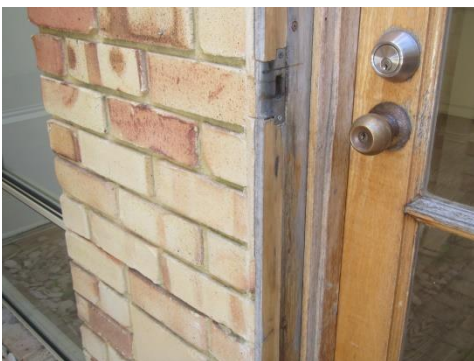
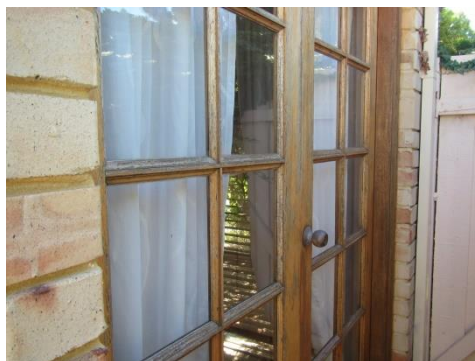
b) External timber work and metal work will require repainting.

c) The timber joinery is showing signs of deterioration. It is recommended maintenance be carried out to prevent further deterioration.

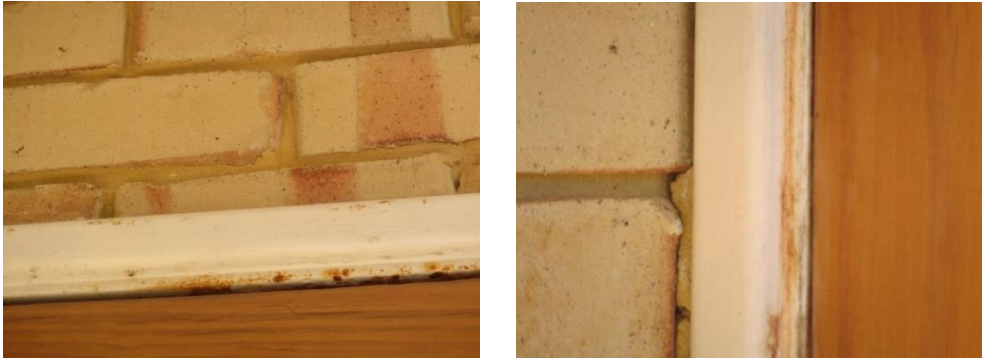
d) The metal door frame to the Garage is showing signs of rusting. It is recommended treatment be carried out to prevent further deterioration.

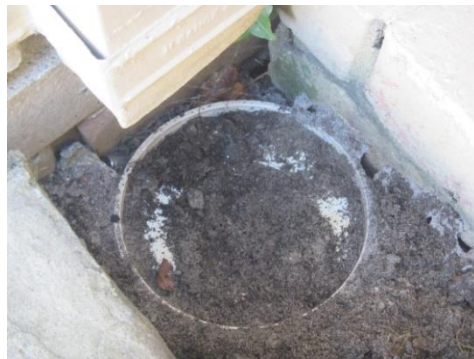
e) The pipework to the downpipe behind the wall at the front left hand corner of the house is full of sand. No undermining of the footings is occurring but it is recommended the pipework be repaired.

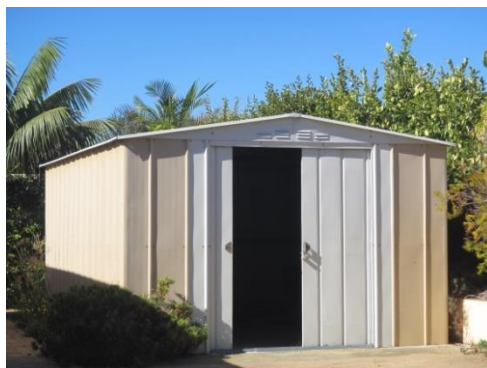
f) The metal garden shed is in a satisfactory condition.
