**PRE-PURCHASE VISUAL
STRUCTURAL INSPECTION
REPORT No. 822**

PROPERTY ADDRESS: Mindarie

DATE: 20 April 2017 TIME: 9.00am WEATHER: Fine

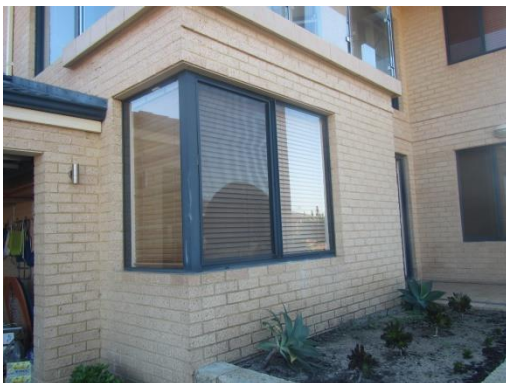
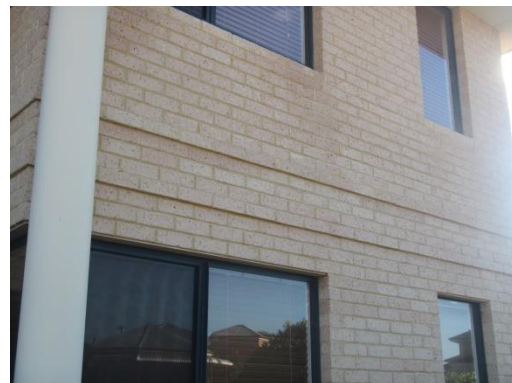
- a) The external face brick walls, where viewed, are in good condition for the age of the property and show no evidence of any major structural faults.
- b) A few movement cracks were noted which are typical in established homes. These cracks appear to be caused by minor settlement and are of no structural concern. It is always recommended to monitor cracking and consult a structural engineer if further movement occurs.

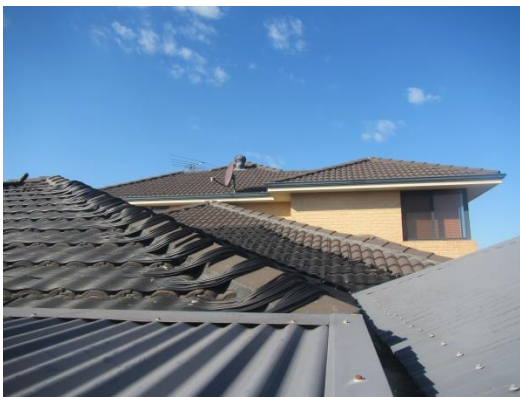
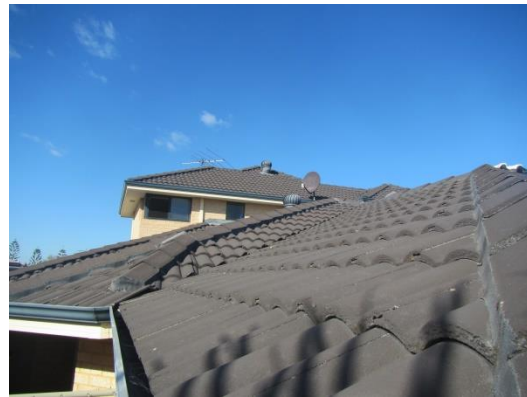
a) The concrete tiled roof, in areas viewed, is in a satisfactory condition for the age of the property and there did not appear to be any major sagging issues.

Note: Viewing was limited to the top storey.

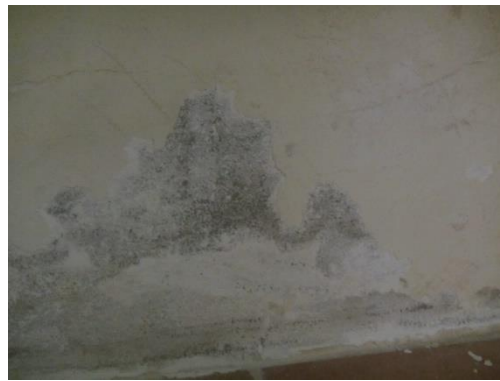
c) It appears the **shower** grouting to the Bathroom and Ensuite may have broken down and caused moisture damage to the reverse side of the wall. This is a very common issue with showers. Generally dampness issues are not part of a structural inspection, but in the opinion of the inspector, because the readings from a moisture meter were very high and dampness has penetrated to the adjoining room it could be deemed a defect and possible health issue. It is recommended the cause be confirmed and the shower resealed by a professional company. Refer to the terms of the offer and acceptance to confirm liability for the rectification work.

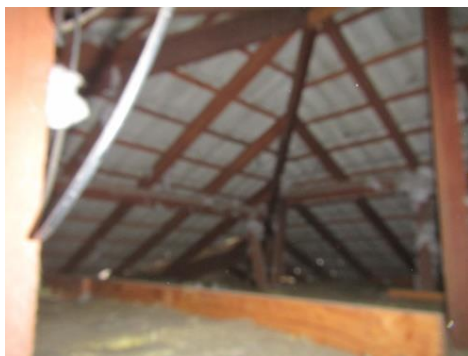
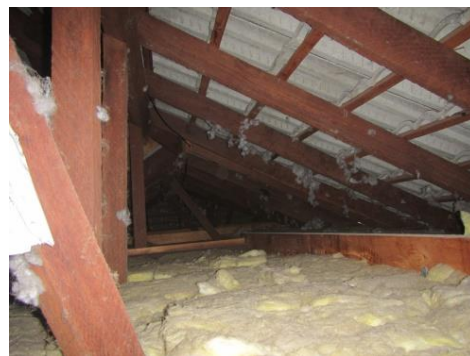
UPPER FLOOR

a) The roof structure of the main house is of timber construction and found to be in a satisfactory condition and appears to have performed adequately. The roof is constructed with W.A. hardwoods and pine and where observed was found to be in a reasonable and stable condition, generally straight and solidly built. The roof was inspected from a manhole in the ceiling.

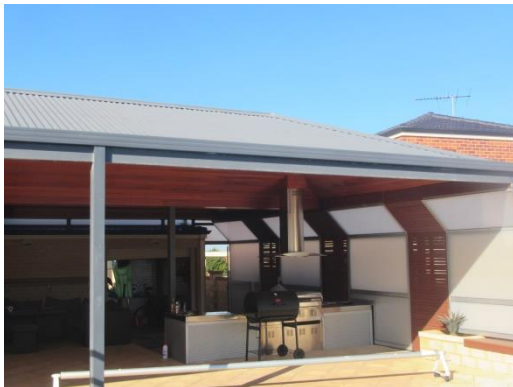
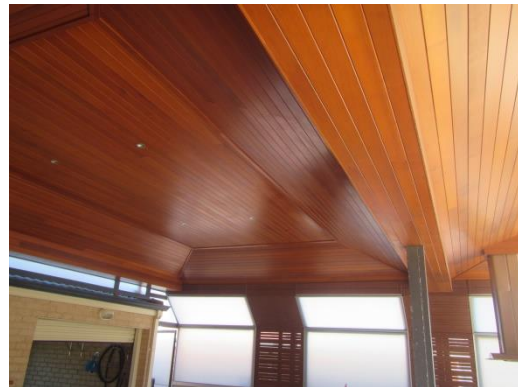
a) The roofed Patio generally is in sound condition and the metal roof structure appears to be performing adequately. **See condition below.**

b) The metal members are showing signs of oxidation and rusting. It is recommended these areas be treated to prevent further deterioration.

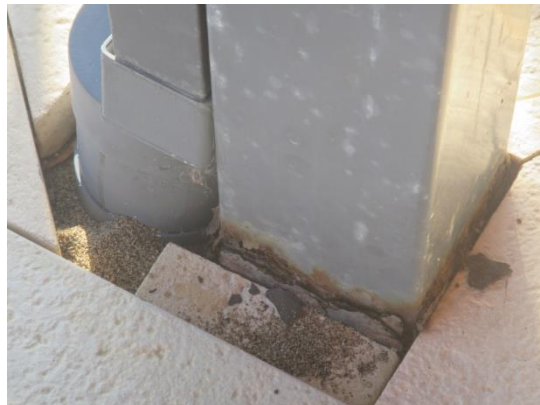
c) The metal posts have rusted severely at the base causing a weakness and in the opinion of the inspector is deemed a structural defect. Due to the extent of the rusting there is a strong possibility the post could fracture in heavy winds. It is recommended the post be rectified by a qualified person.

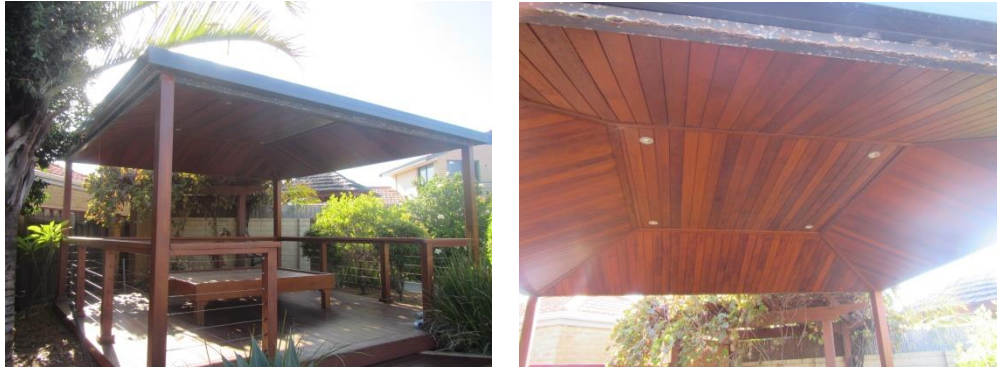
a) The roofed Patio generally is in sound condition and the metal roof structure appears to be performing adequately. **See condition below.**

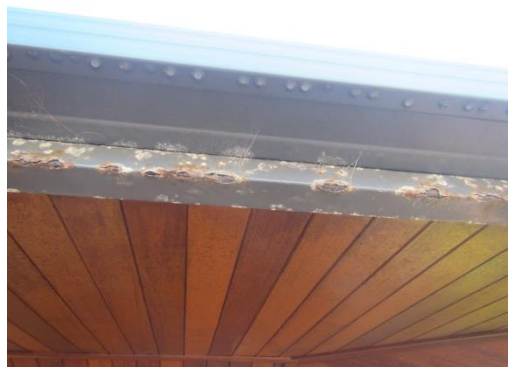
c) The metal beams have substantial rust in areas causing the metal to flake. In the opinion of the inspector the degree of rusting is deemed unacceptable and treatment is required to be carried out by a qualified tradesman.

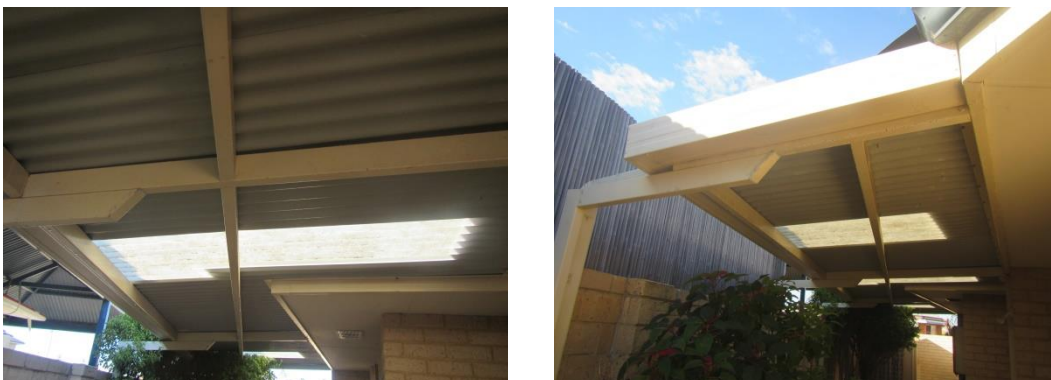
a) The roofed Patio generally is in sound condition and the metal roof structure appears to be performing adequately. **See condition below.**

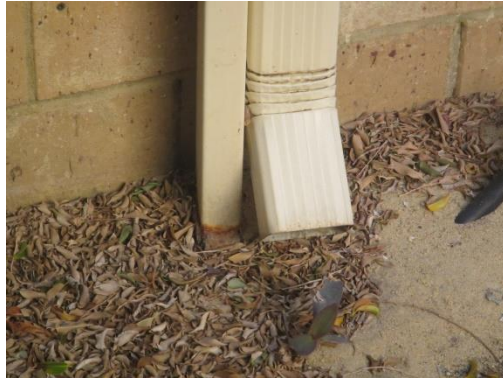
b) The metal posts have rusted severely at the base causing a weakness and in the opinion of the inspector is deemed a structural defect. Due to the extent of the rusting there is a strong possibility the post could fracture in heavy winds. It is recommended the post be rectified by a qualified person.

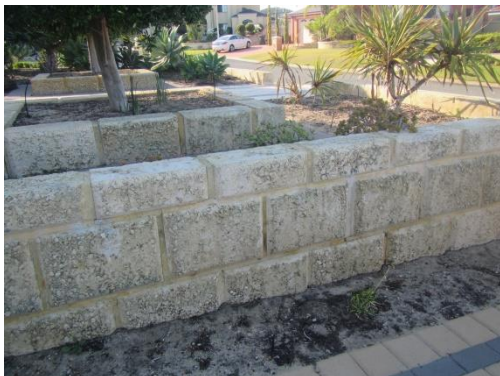
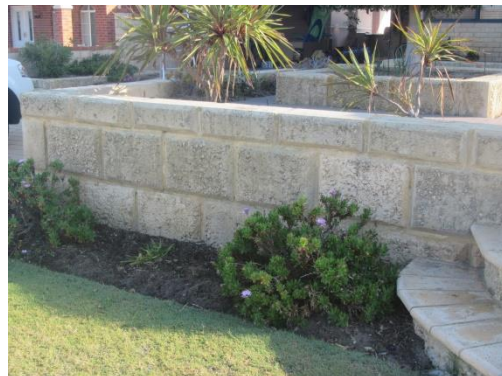
a) The limestone retaining wall is in a satisfactory condition and no major failure was observed. Some movement cracks were noted which should be monitored. Contact a structural engineer if any movement continues.

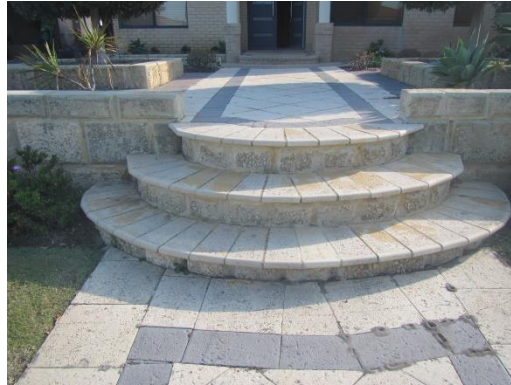
a) The paved steps are in a satisfactory condition.
