KEVIN BURNS HOMES

PRACTICAL COMPLETION REPORT

VISUAL BUILDING INSPECTION REPORT No. 764

PROPERTY ADDRESS: Jindalee

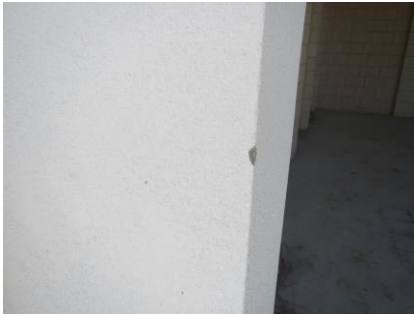
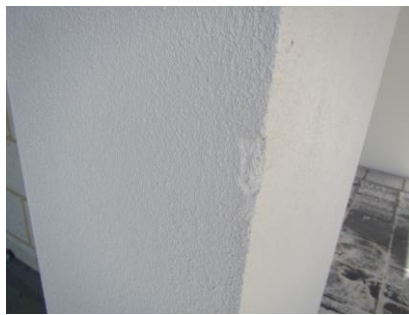
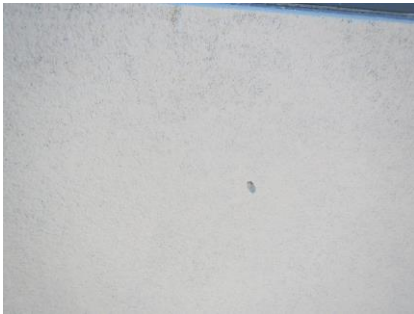
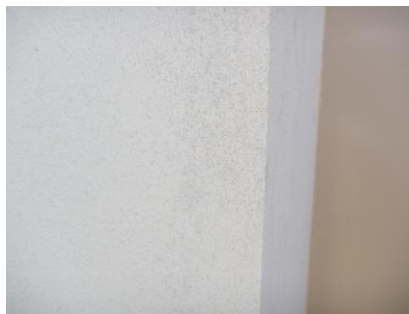
1) Repair chips on render on both edges of Garage opening. Clean marks of render and repaint under right hand window and right hand corner.

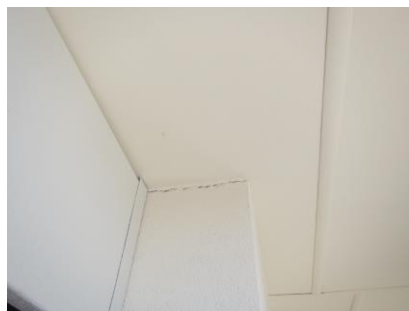
2) Repatch between render and eaves.

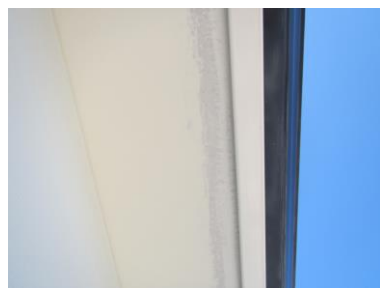
3) Complete eaves painting.

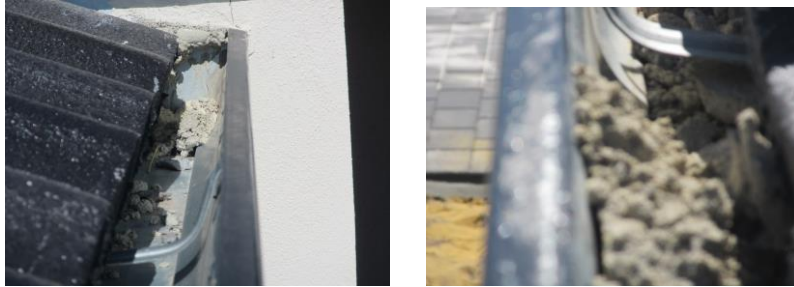
5) Rubble is in the gutters in a number of places. Check the perimeter of the home and remove the rubble.

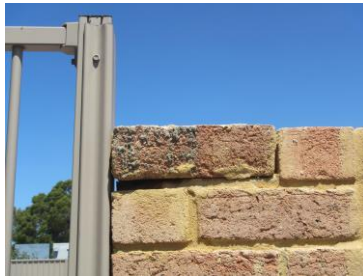
10) Relay face brick on fence. It appears this was damaged when metal fence was installed.

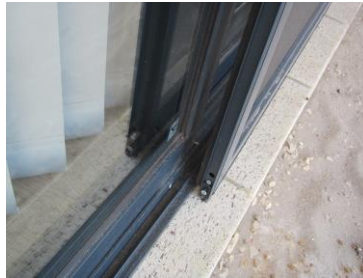
14) Family Room sliding door is off its track.

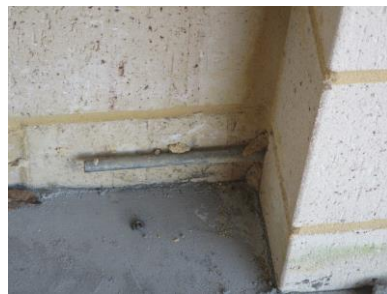
18) Cut metal rod protruding from pier.

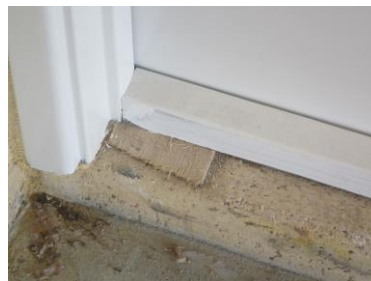
20) Remove packer from door sill.

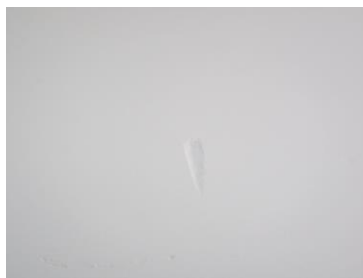
- 22) Touch up internal and external of front door frame. Paint sill.
- 23) Adjust front door. It appears the door has bowed slightly.
- 24) Clean all striker plates to internal door frames.
- 25) Check all doors for rubbing on carpet. Example Bedroom 1.
- 26) Various door frames have chips and marks. Check all door frames and touch up.
- 27) Check all window reveals. Plastering is rough in areas.
- 28) Check all window frames. Marks require cleaning off in areas.
- 29) Fit grate to Ensuite shower.
- 30) Remove marks on tiles to Ensuite above power point over vanity and just on left hand side above the shower taps .
- 31) Clean paint off Ensuite cupboard handles.
- 32) The Ensuite door hits the towel rail when opened. It may be necessary to fit a stopper on the floor or see if a small clear buffer can be put on towel rail. Discuss with client.
- 33) Patch chip on wall to Bedroom 1.
